# Risk In a PV Installation

## A Thermarestor view

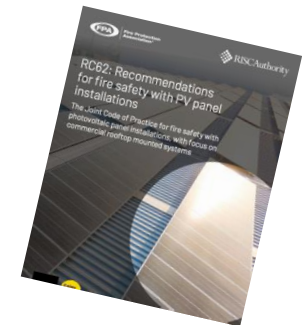
BRE 2017 Study. 'PV components most likely to develop faults that led to a fire incident'

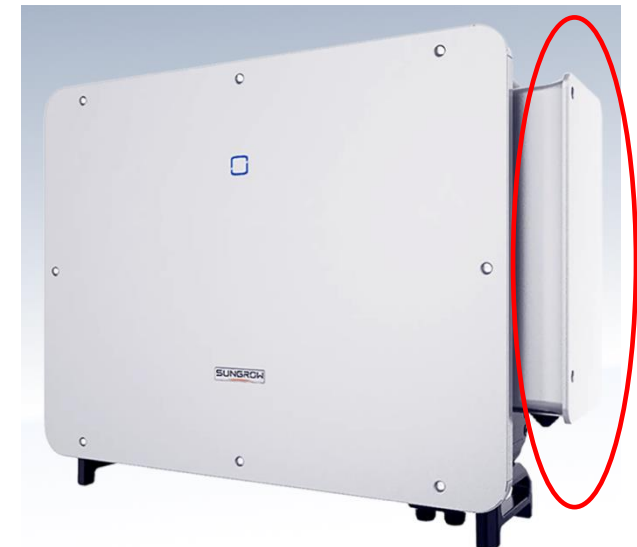
Site terminated AC connections in accessible chamber

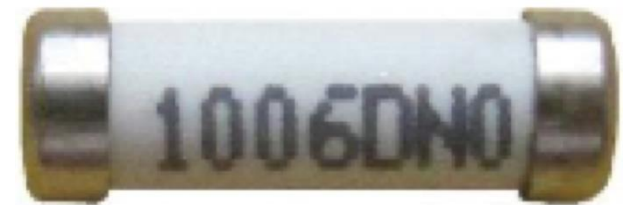
Our unique and patented **thermal sensor** that sits on electrical connection points and activates at  $\approx 80^{\circ}\text{C} (\pm 5^{\circ}\text{C})$  — well before ignition, letting someone know, turning a potential fire into a simple maintenance event.

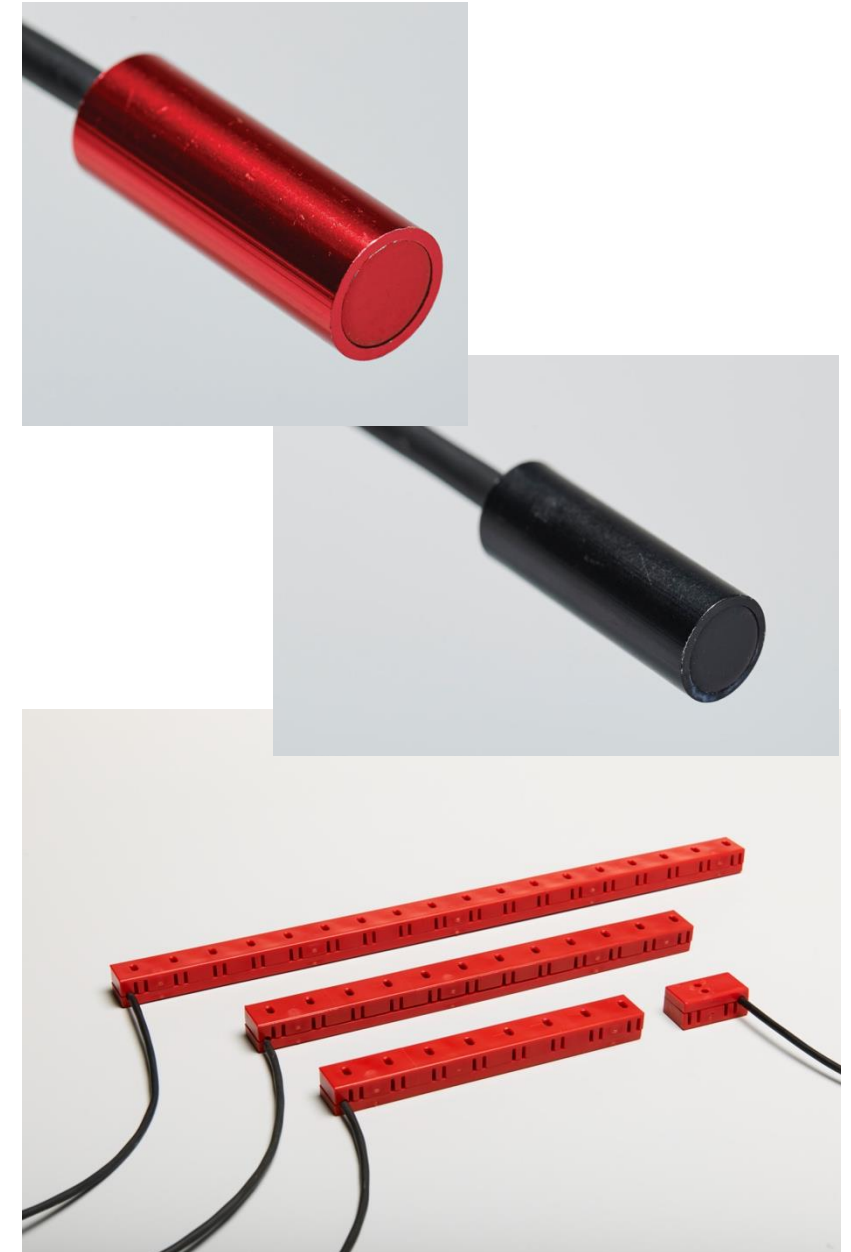
Three unique, patented sensor types:

- **SinglePoint (T1150/T1155)** — monitors one connection.
- **MultiPoint (T1102–T1118)** — protects multiple terminals / connections.

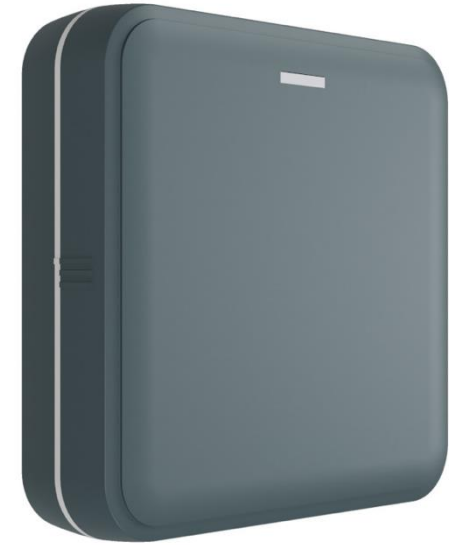
The link between the sensors and the cloud monitoring portal

- Self Contained GPS unit
- Battery operated – 18 month life
- No power supply required

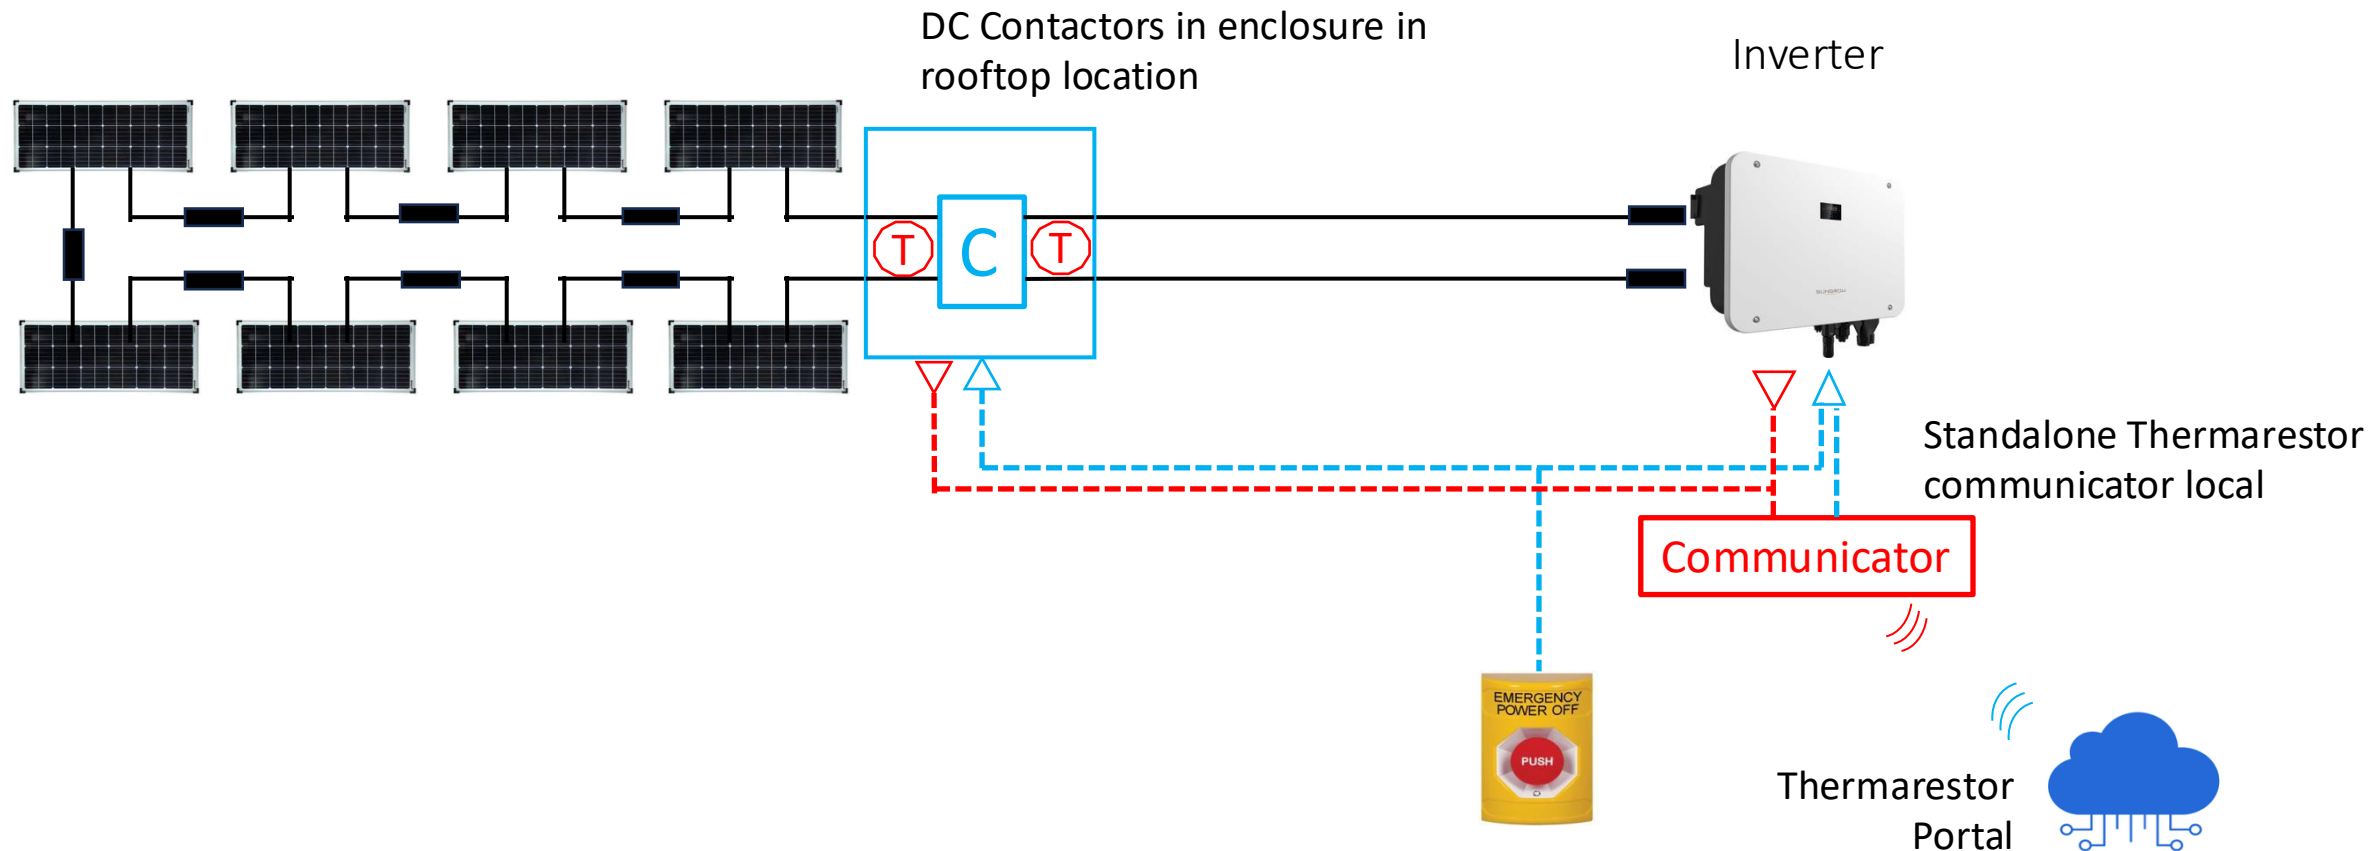
# Install DC contactors in IP rated enclosures local to the modules – Control and Protection
